Final-- October 15, 1987

Preliminary Assessment
Rakonen Drum Site
Brigham City, Utah
UT0981545987

Preliminary Assessment
Rakonen Drum Site
Brigham City, Utah
UTD981545981

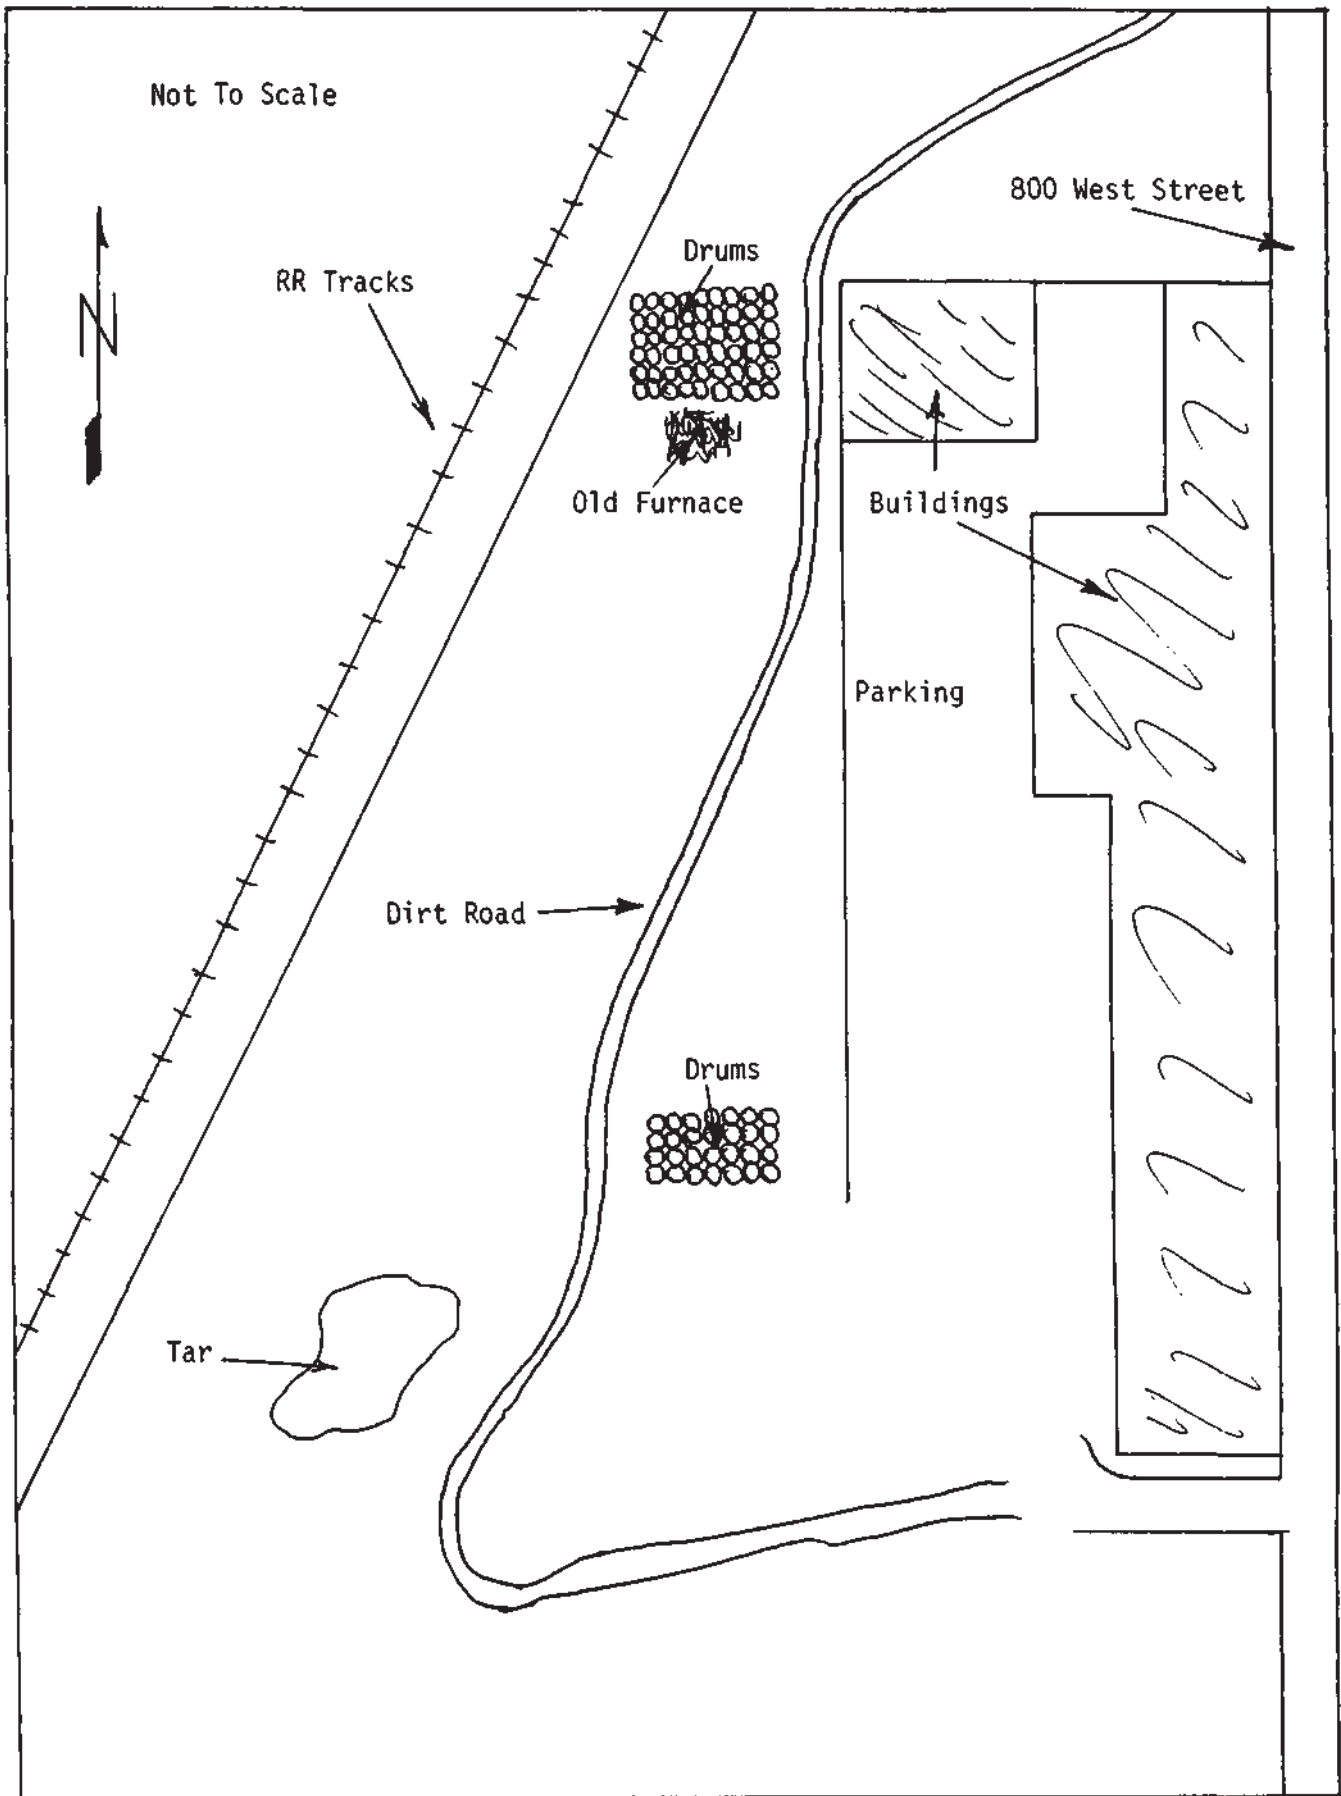
Figure 2 - Site Sketch

The Rakonen Drum Site (RDS) is located at 112 South 800 West in Brigham City, Utah (see Figure 1). The entire property (illustrated in Figure 2) is currently owned by Arnold Thompson. John Rakonen is the owner of the drums.
